# **Mobile Intel<sup>®</sup> Pentium<sup>®</sup> II Processor Specification Update**

Release Date: May 2002

Order Number: 243887-040

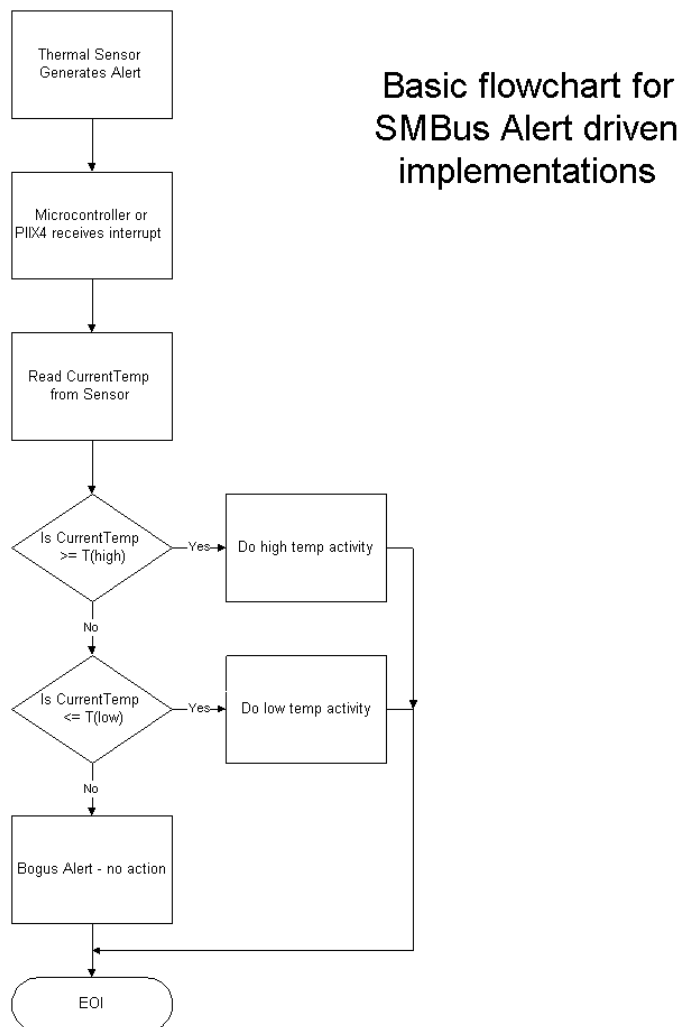
**Figure 2. Workaround Flowchart: SMBALERT#-Driven System**

Under the conditions described below, the thermal sensor incorrectly generates the SMBALERT# interrupt. All of the following conditions must be met to trigger a false interrupt:

1. Before servicing an interrupt from the thermal sensor, read and compare the processor thermal reading with the threshold limits ( $T_{HIGH}$  or  $T_{LOW}$ ). Figures 2 and 3 provide basic flowcharts for the implementation of this workaround in an interrupt driven system.
2. If the firmware implemented polls the Status Register only, then before taking any action, re-read the temperature register and do a comparison with the alarm threshold limits ( $T_{HIGH}$  or  $T_{LOW}$ ) to determine if the value is actually still within the temperature window.
